**HAZARDOUS MATERIALS
INVENTORY SURVEY**

**Simon Fraser Hills
Burnaby, BC**

**Strata Plan NW39
c/o Bayside Property Services Ltd.
#100-6400 Roberts Street
Burnaby, BC
V5G 4C9**

February 23, 2017

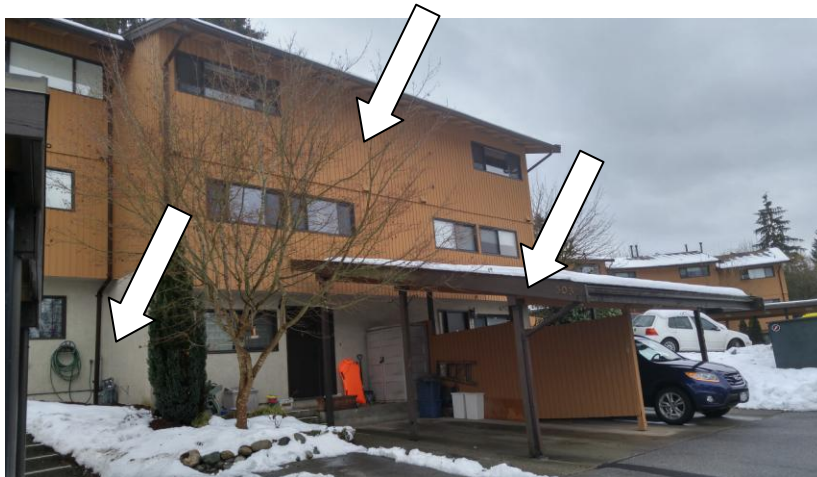
Lead containing orange and brown paint with non-asbestos containing stucco on the exterior of a unit on Clarina Place

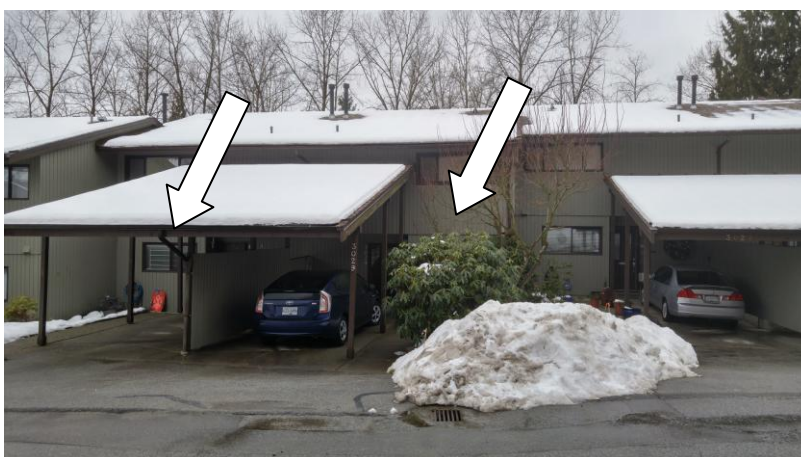
Lead containing green/blue and brown paint on the exterior of a Unit on Clarina Place

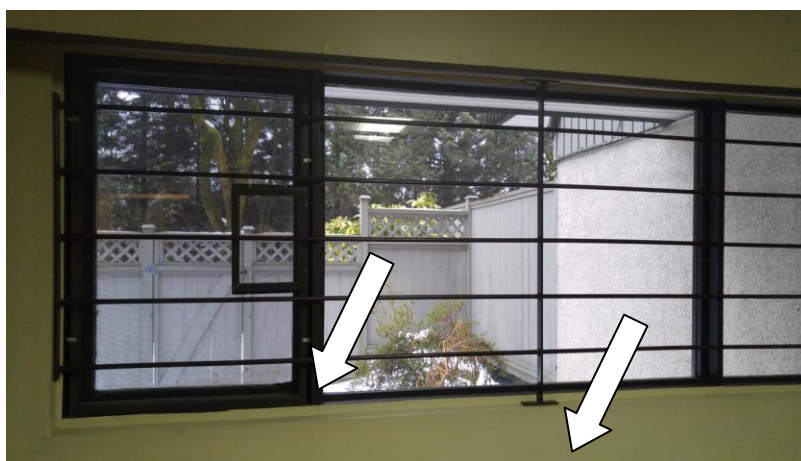
Asbestos containing black window mastic on the basement living room window and asbestos containing drywall in Unit 3033

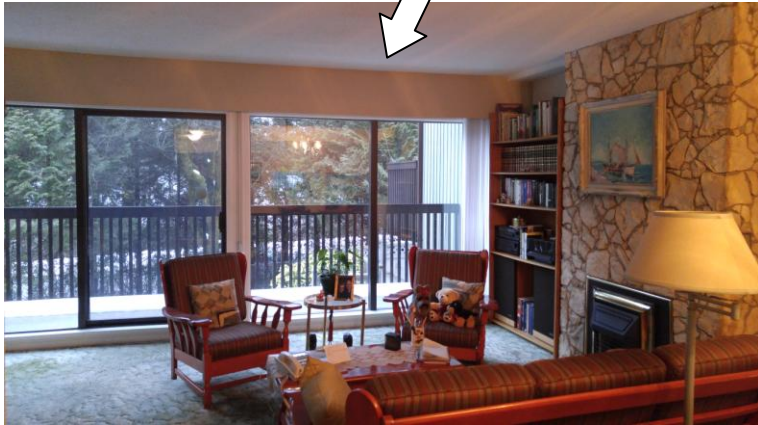
Asbestos containing ceiling texture and drywall in the main floor living room of Unit 3033

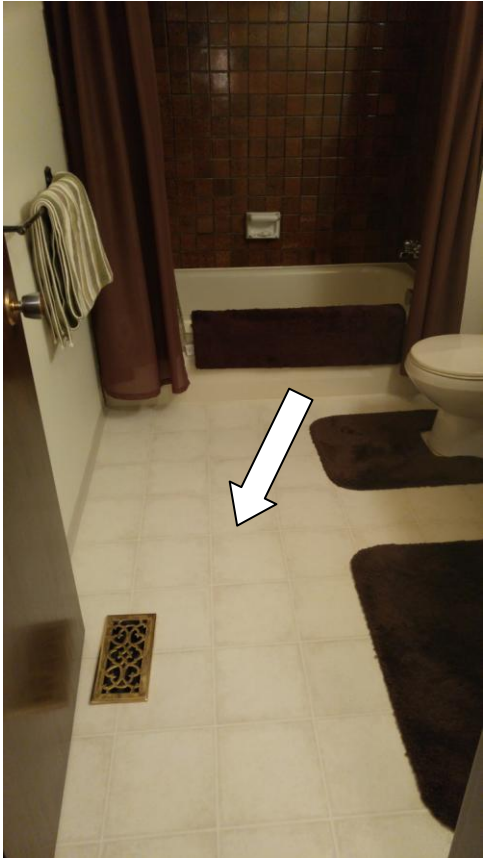
Asbestos containing Linoleum sheet flooring in the upper floor bathroom of Unit 3033

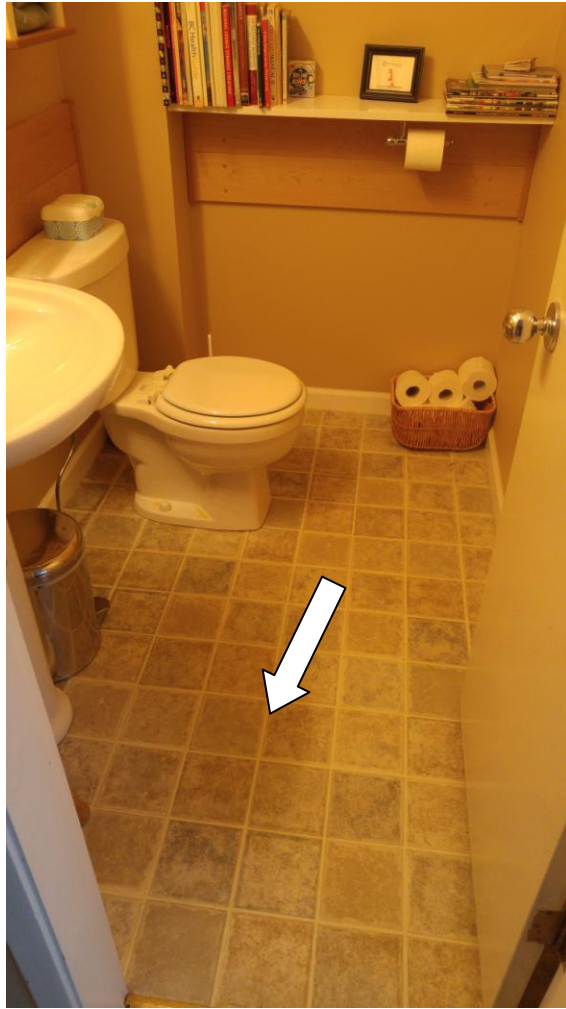
Asbestos containing Linoleum sheet flooring in the upper floor bathroom of Unit 3032

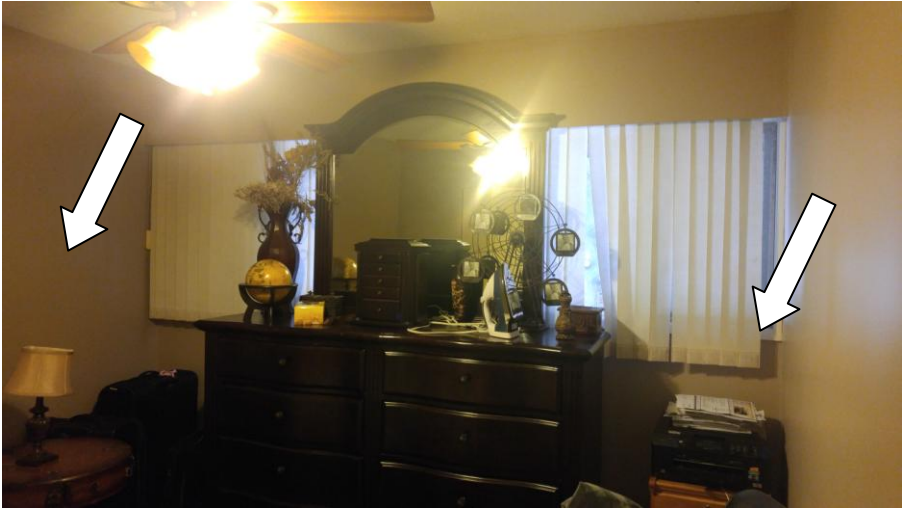
Asbestos containing black window mastic on the 3rd floor bedroom window and asbestos containing drywall in Unit 3036

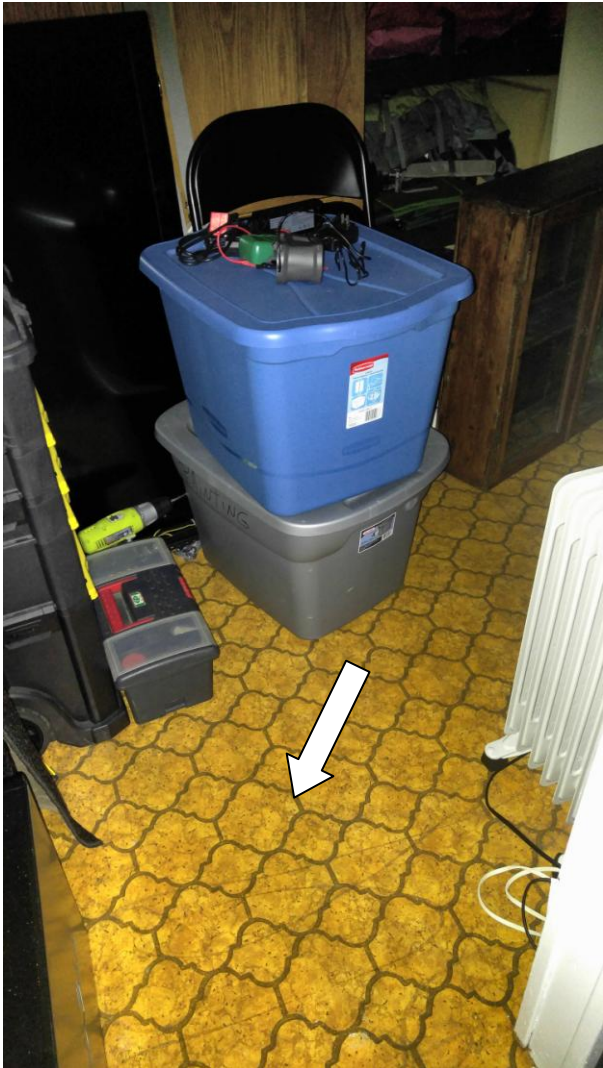
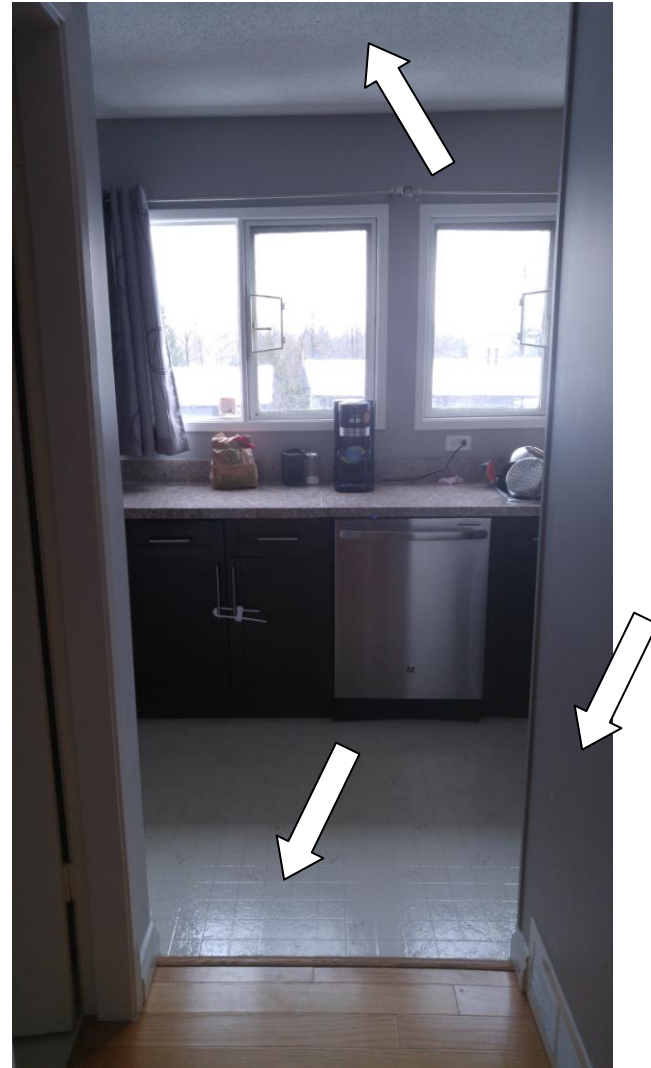
Asbestos containing Linoleum sheet flooring in the basement play room and asbestos containing Linoleum sheet flooring, drywall and ceiling texture in the kitchen of Unit 3036

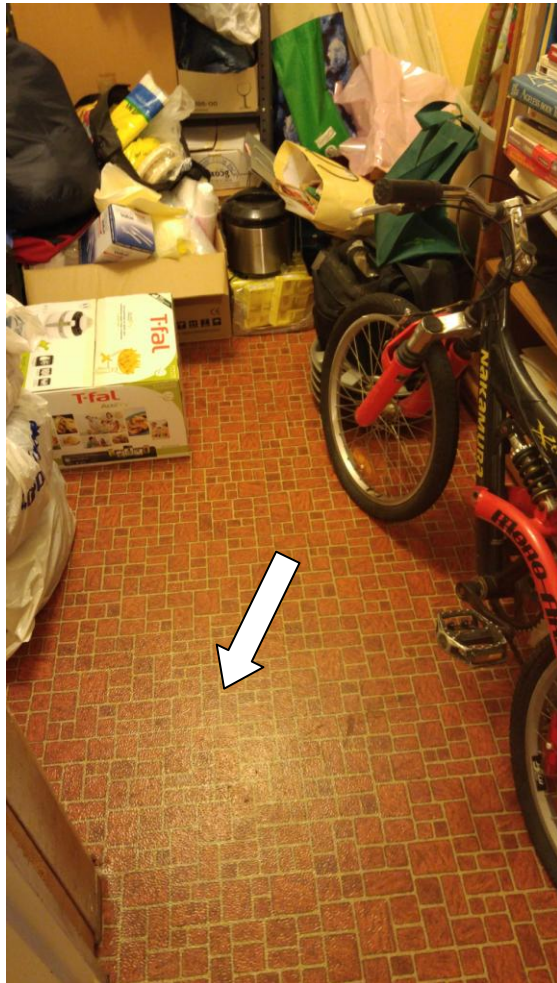
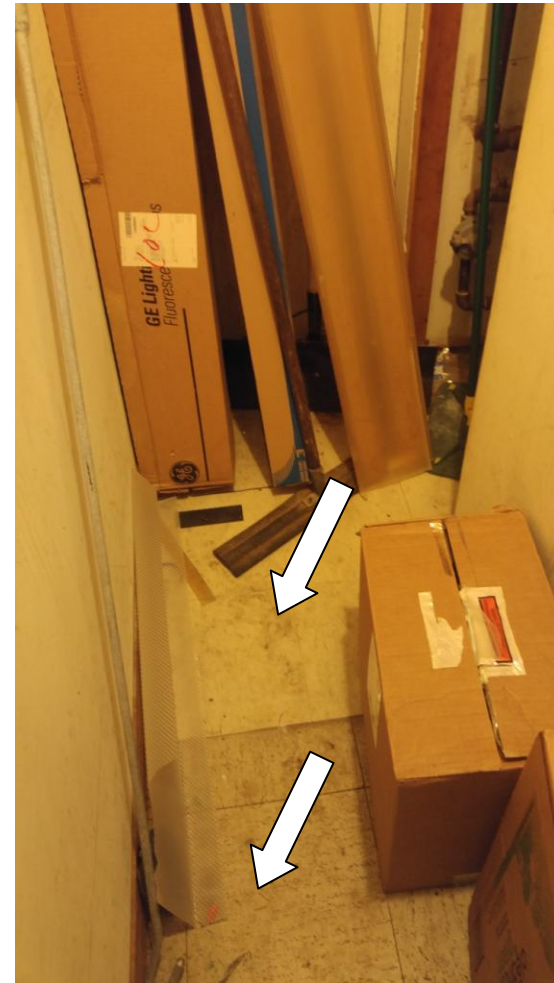
Asbestos containing red Linoleum in the basement of Unit 3051 and asbestos containing 12" white and grey vinyl floor tiles in the pool house janitor closet

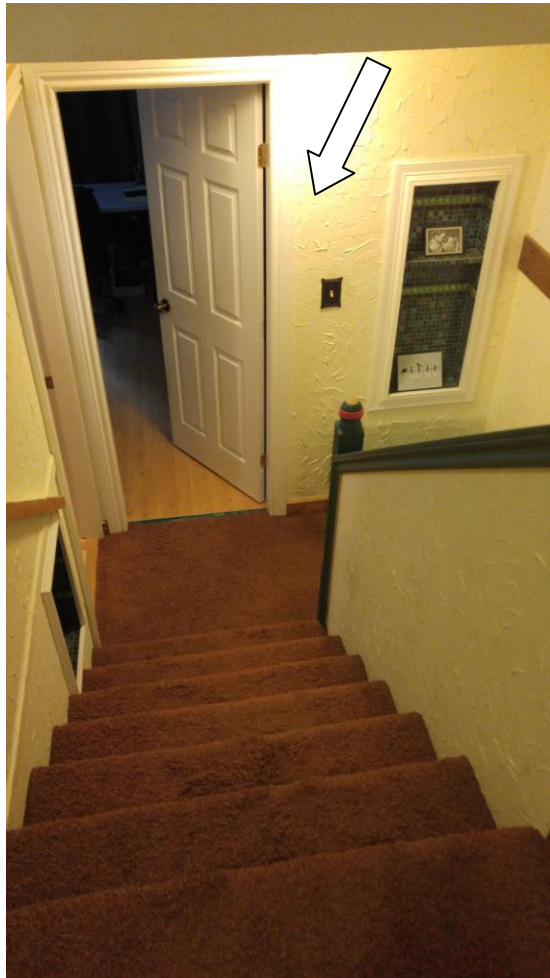
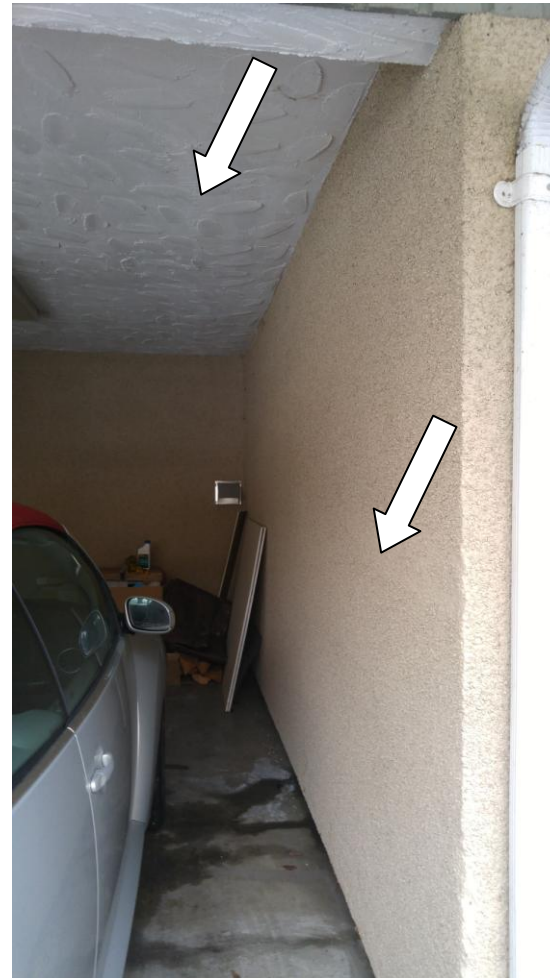
Non-asbestos containing wall texture on asbestos containing drywall in Unit 9042 and non-asbestos containing white and beige stucco outside Unit 9042

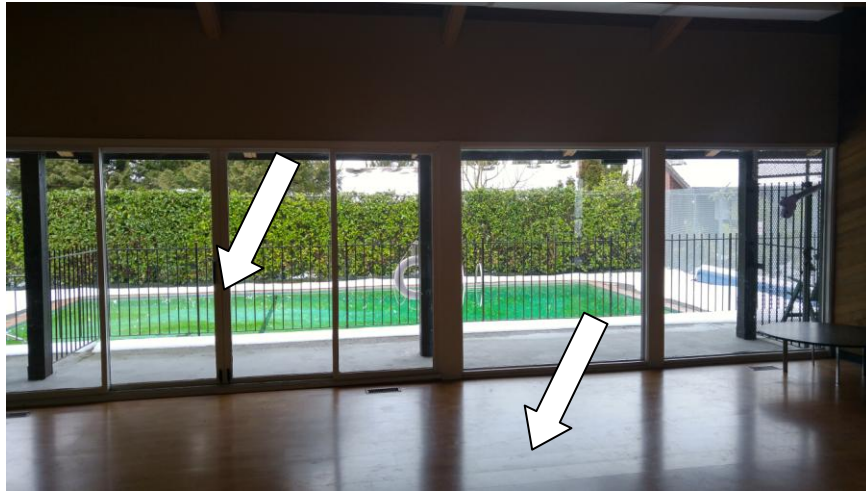
Asbestos containing window glazing mastic on the pool house exterior windows and asbestos containing vinyl flooring in the pool house main area/kitchen

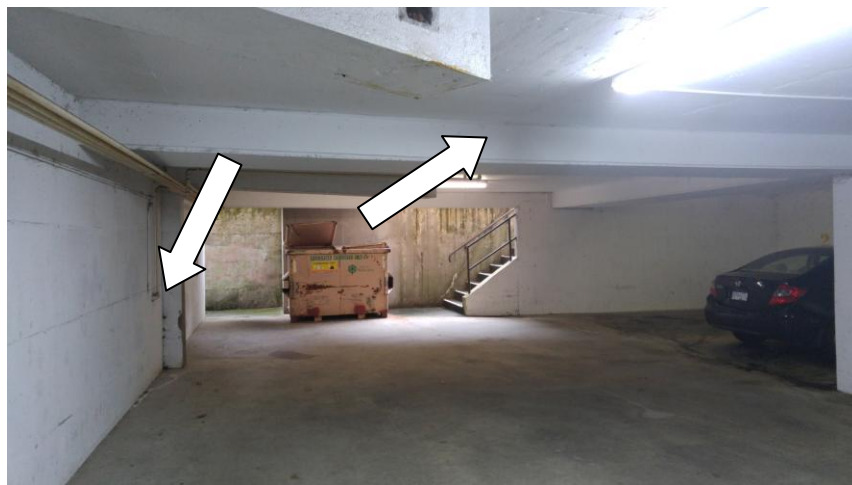
Non-asbestos containing stucco and lead containing white paint in the parkade
